# MERCURY SPACECRAFT EXTERIOR DATA MARKINGS

A FIRST ATTEMPT AT SORTING THEM OUT

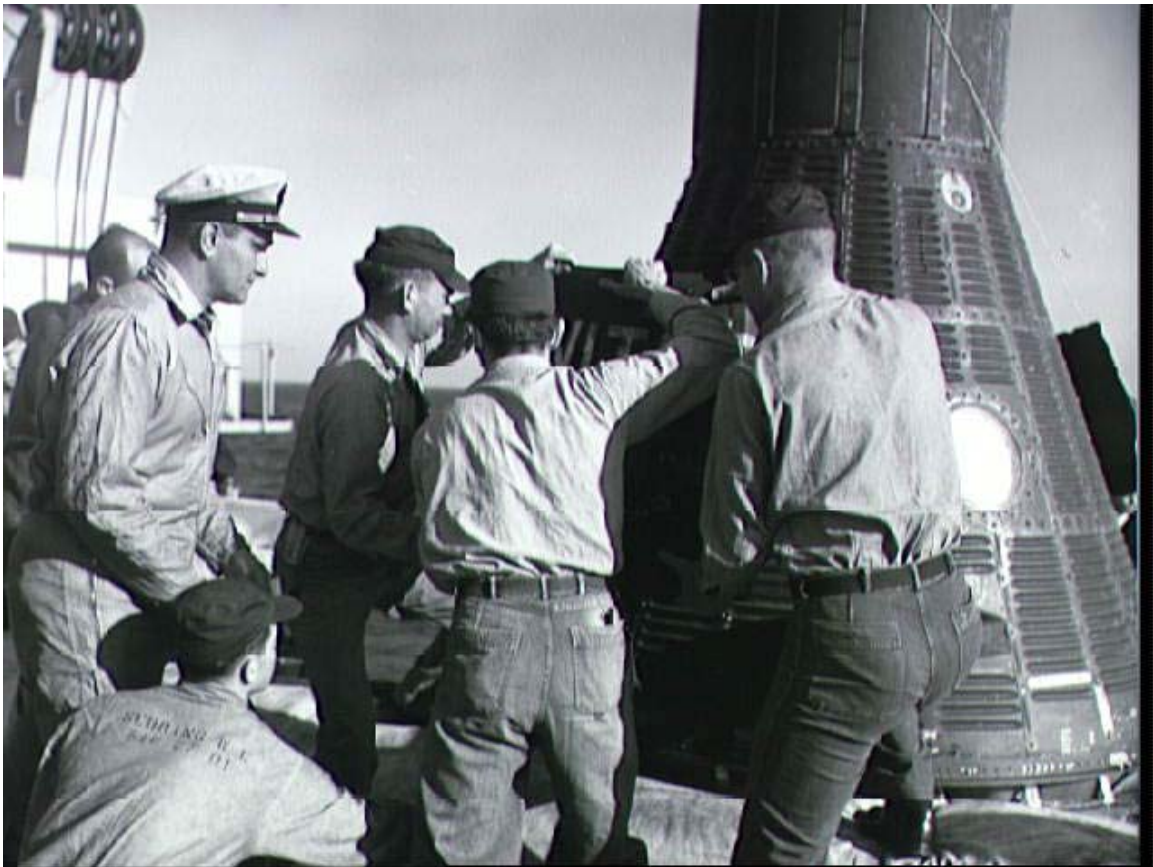
*Figure 1 Recovery of Ham in MR-2*

I know very little about these markings. Figure 1 shows some lettering in the area of (250°, 108''). According to [AFGASweb] this vehicle is in the California Museum of Science and Technology in Los Angeles.

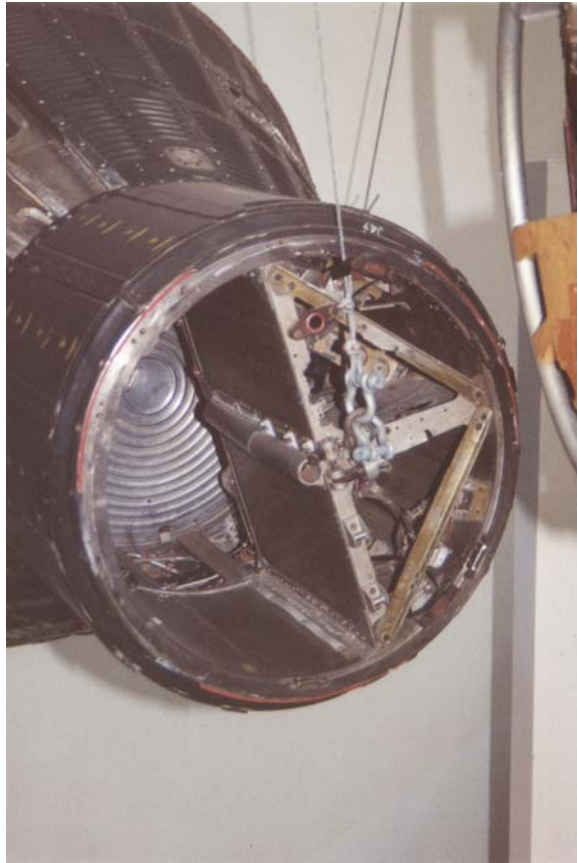
*Figure 2 Recovery compartment of MR-2*

Figure 2 Shows the marking J49 on the forward face of the recovery section.

Figure 13 shows Scott Carpenter practicing egress through the parachute compartment in the recovery section. It is not clear whether this is actually SC 18, or another vehicle. Note the J45 marking in comparison to Figure 2.

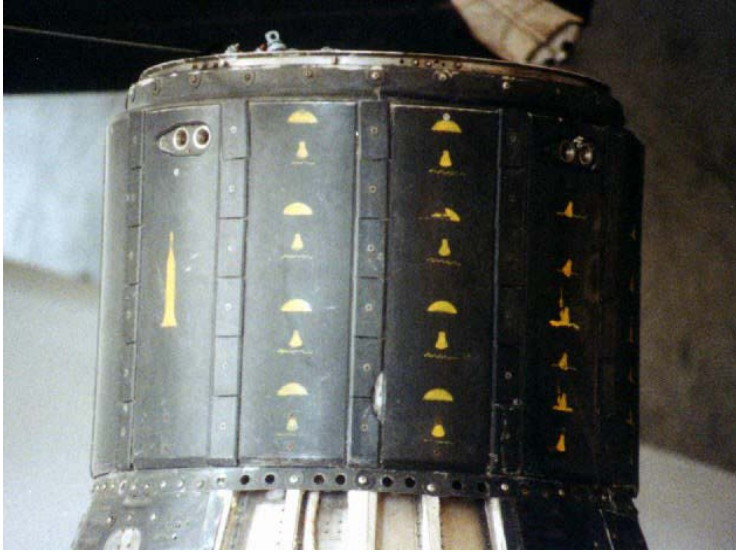
*Figure 3MR-2 Recovery Compartment Markings*

Figure 3 Shows markings which were added after the Ham flight for various drop and retrieval tests.

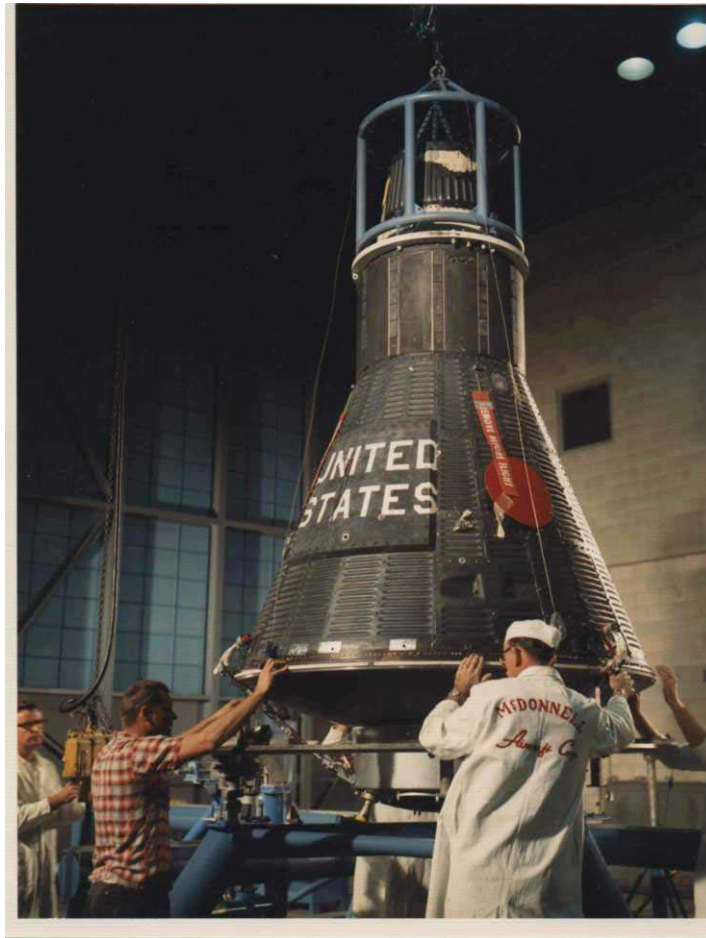
Figure 6 MR-3

I've been unable to find very clear information on the markings of the first manned Mercury spacecraft. Figure 6 indicates some wording near the heat shield, but nothing can be read. The vehicle is now on display at the US Naval Academy in Annapolis MD.

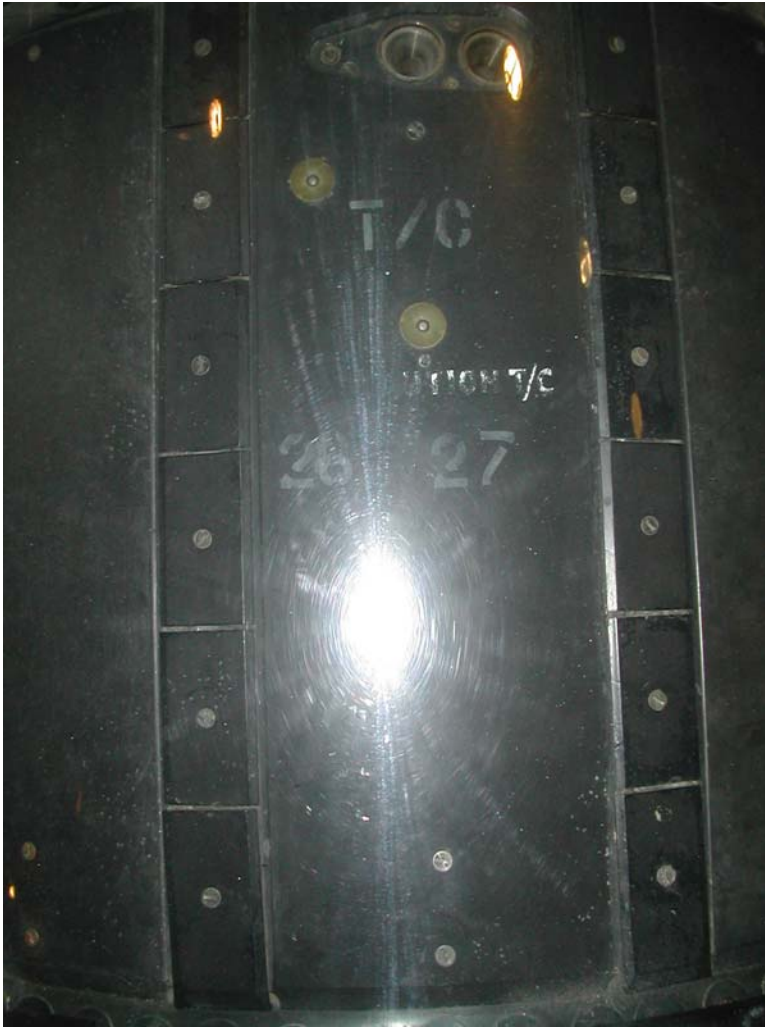
*Figure 7 Recovery Section at TY*

The recovery section has markings which include some kind of numbering as well as the locations of thermocouples. Figure 7 shows the recovery section at TY (or 0°). Note the large T/C under the RCS nozzle, and the smaller CAUTION T/C markings as well as the number 26 and 27.

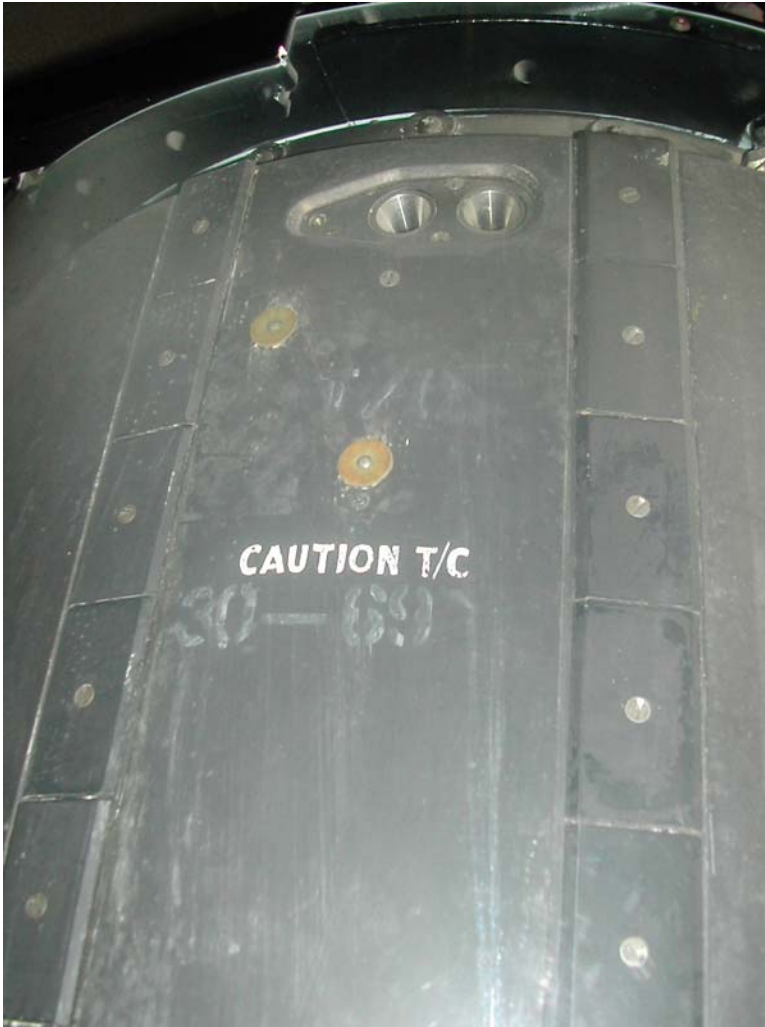
*Figure 8 Recovery Section at LX*

Figure 8 is similar except for the numbering.

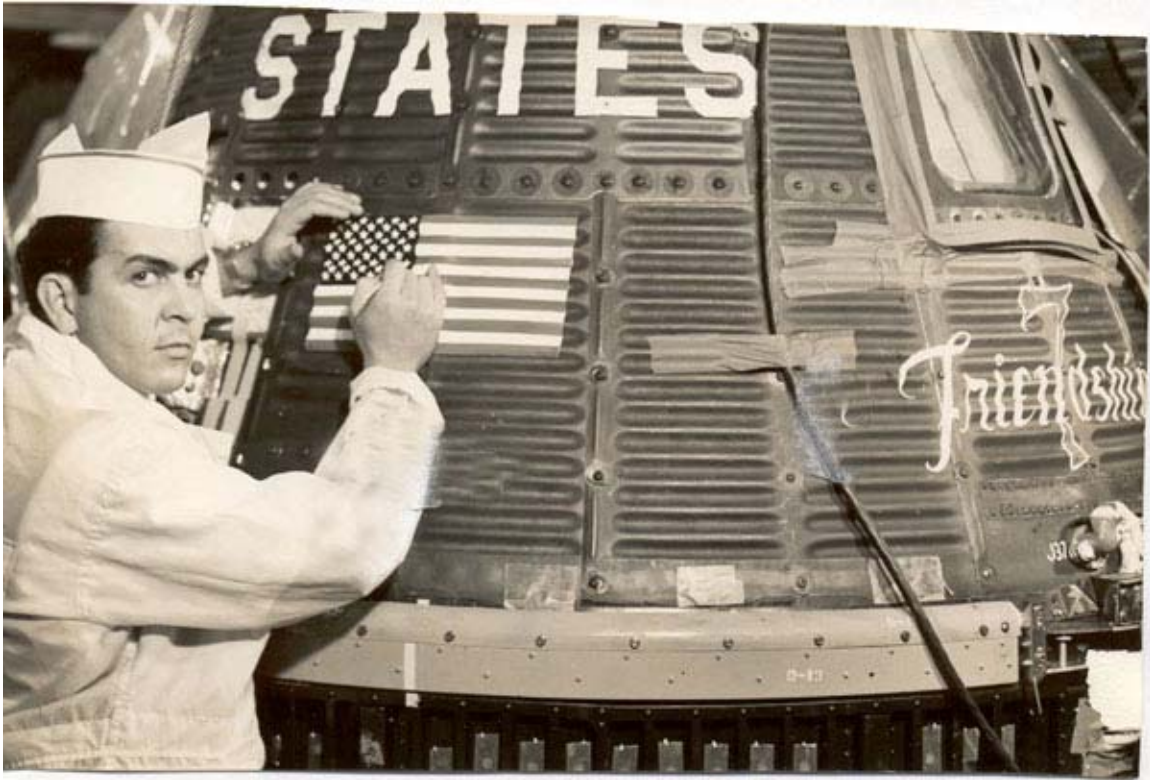
*Figure 9 Howard Perez and the US Flag on SC 13*

Figure 9 appears on Cece Bibby's web site; note the lack of markings similar to those on the Enos craft.

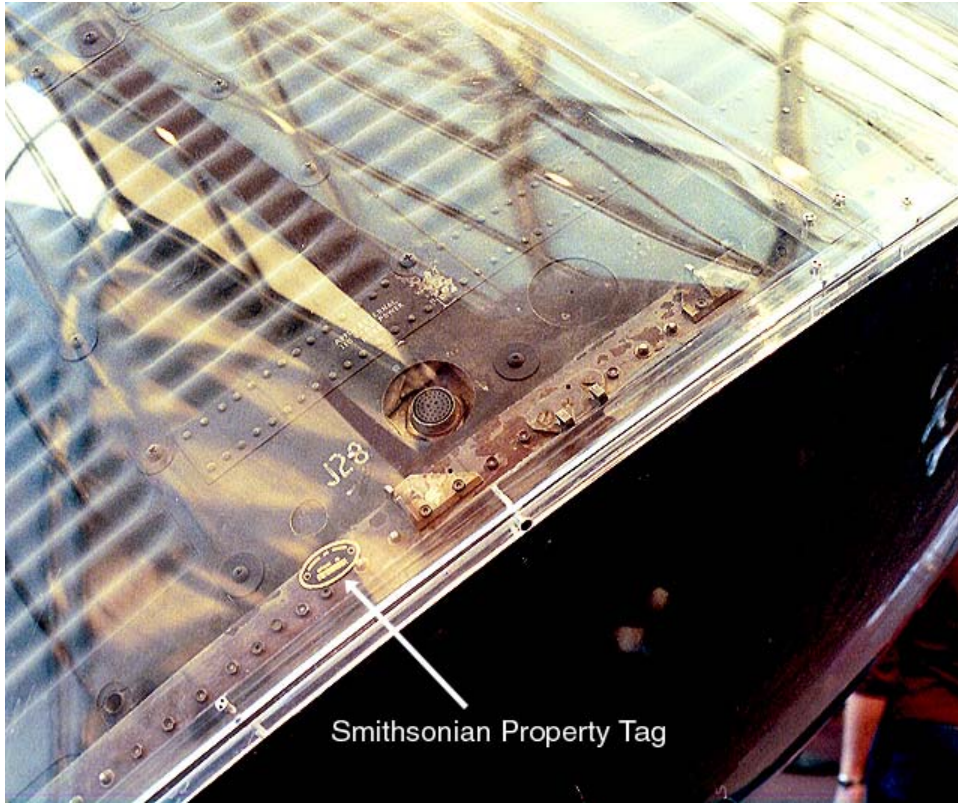
*Figure 10 SC13 J28*

Figure 10 is one of several photos of SC13 posted to the Yahoo Spacemodeler's group by Drew<sup>2</sup> in October 2000. Note the J28 and J12 markings. Also of note is the label at (125, 110) above the J28 connector which reads

APPLY EXTERNAL  
115V AC POWER  
HERE

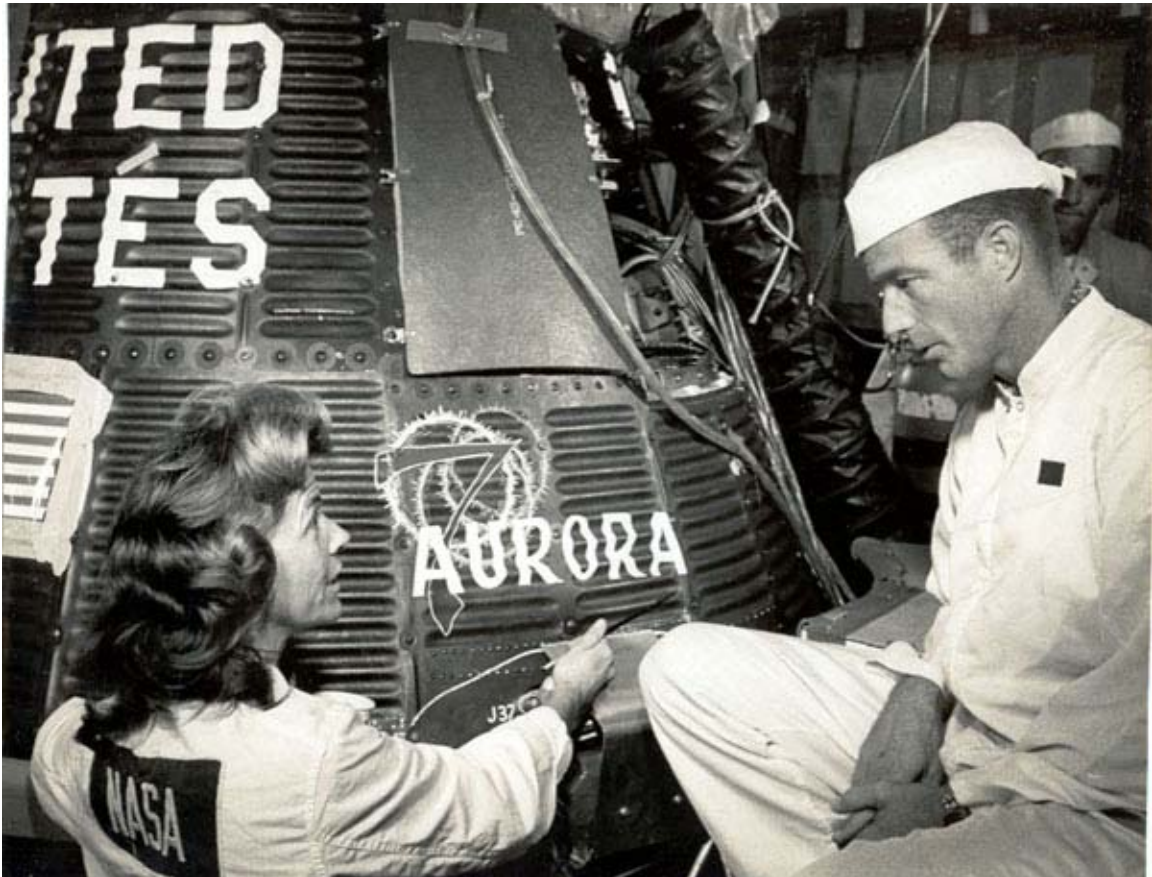
Figure 11, also from Cece Bibby's site, bears close inspection. If you look carefully at the next to bottom bead on the shingle just above her head, just below and to the right of the S in STATES, there is some evidence of a data marking inside the bead. In comparison to photos of later spacecraft, I am inclined to believe that this is so, and that it is probably a thermocouple location. The wording is most likely CAUTION TEMP P/U which is the form which appears on later spacecraft.

Figure 14 is very similar to Figure 11. In this picture the caution marking inside the bead is more legible. Note that it is now one bead lower.

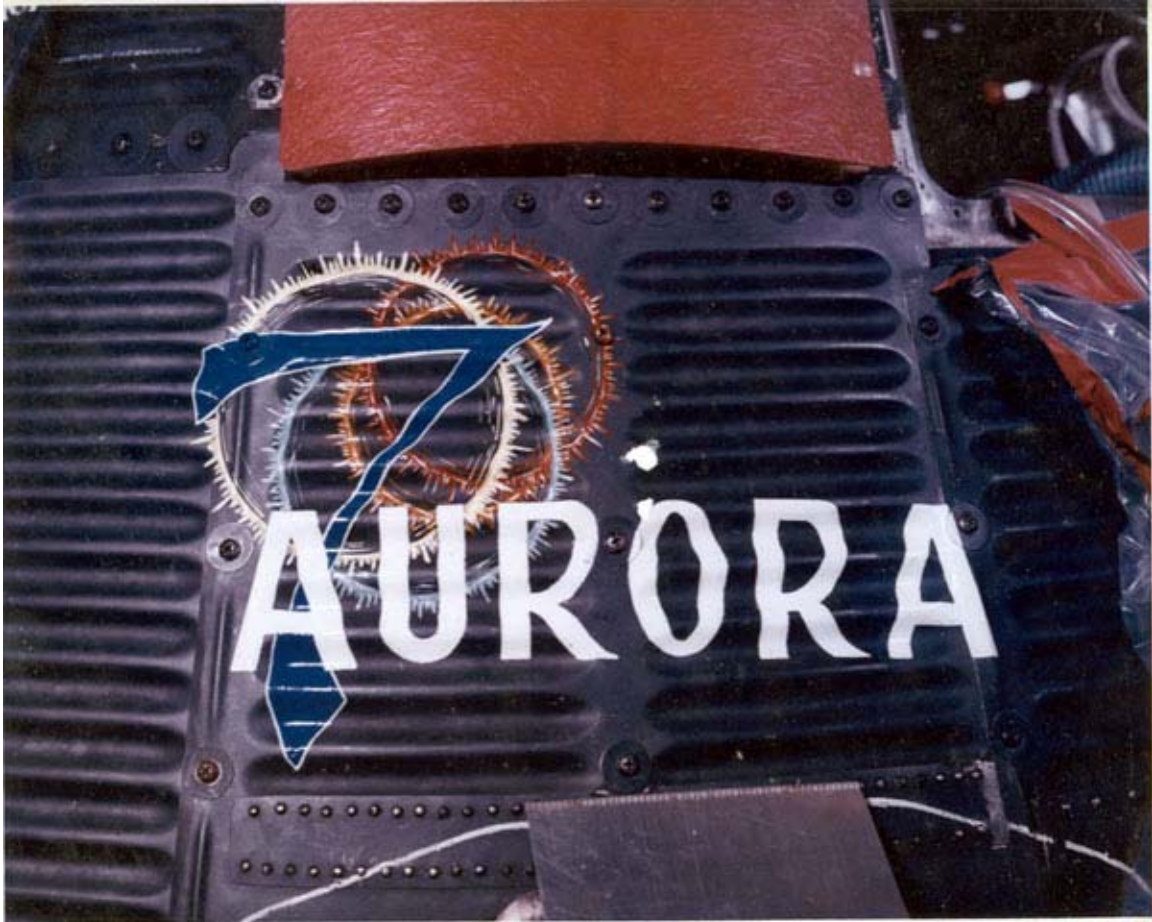
Figure 12, another from Cece Bibby's site, is included to show the actual colors of the Aurora 7 logo. The markings on the spacecraft did not stand up well to re-entry conditions. This applies both to the art markings as well as the data markings. Note that the 7 in the logo is blue, not red as it is sometimes depicted.

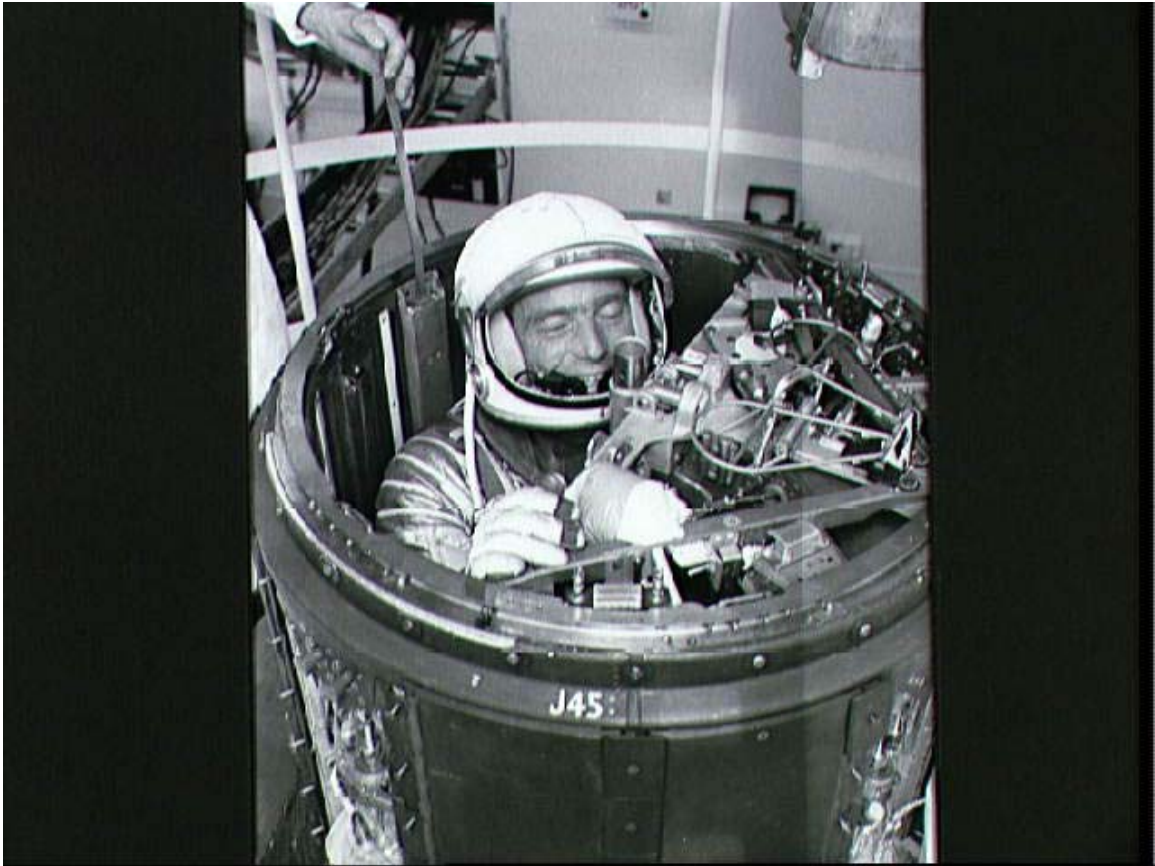
*Figure 13 Scott Carpenter practicing egress*

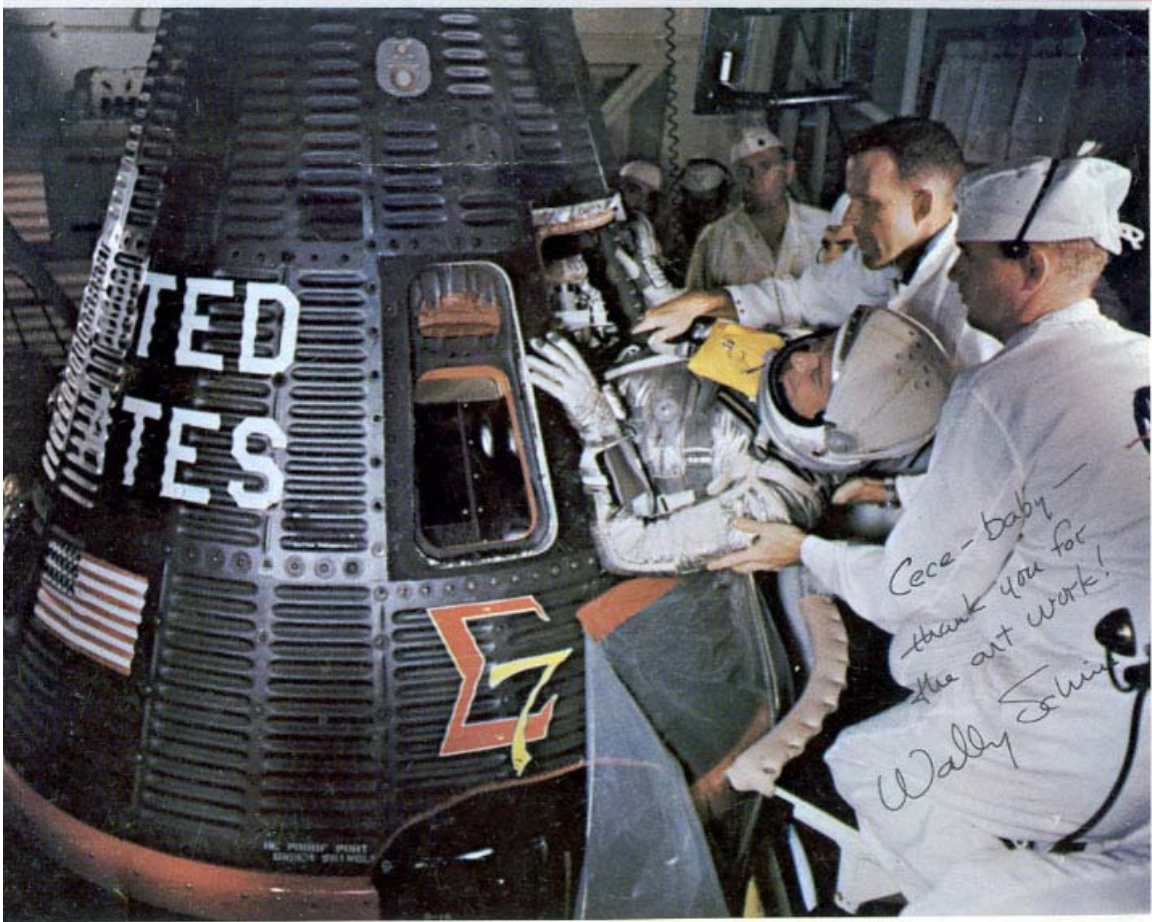
*Figure 15 Shirra insertion into SC 16*

Figure 15, shows the same data marking just discussed, as well as one at the same angular position just above the booster attachment ring. I cannot make out the wording by I believe that it begins with HYD. PEROXIDE and ends with SHINGLE.

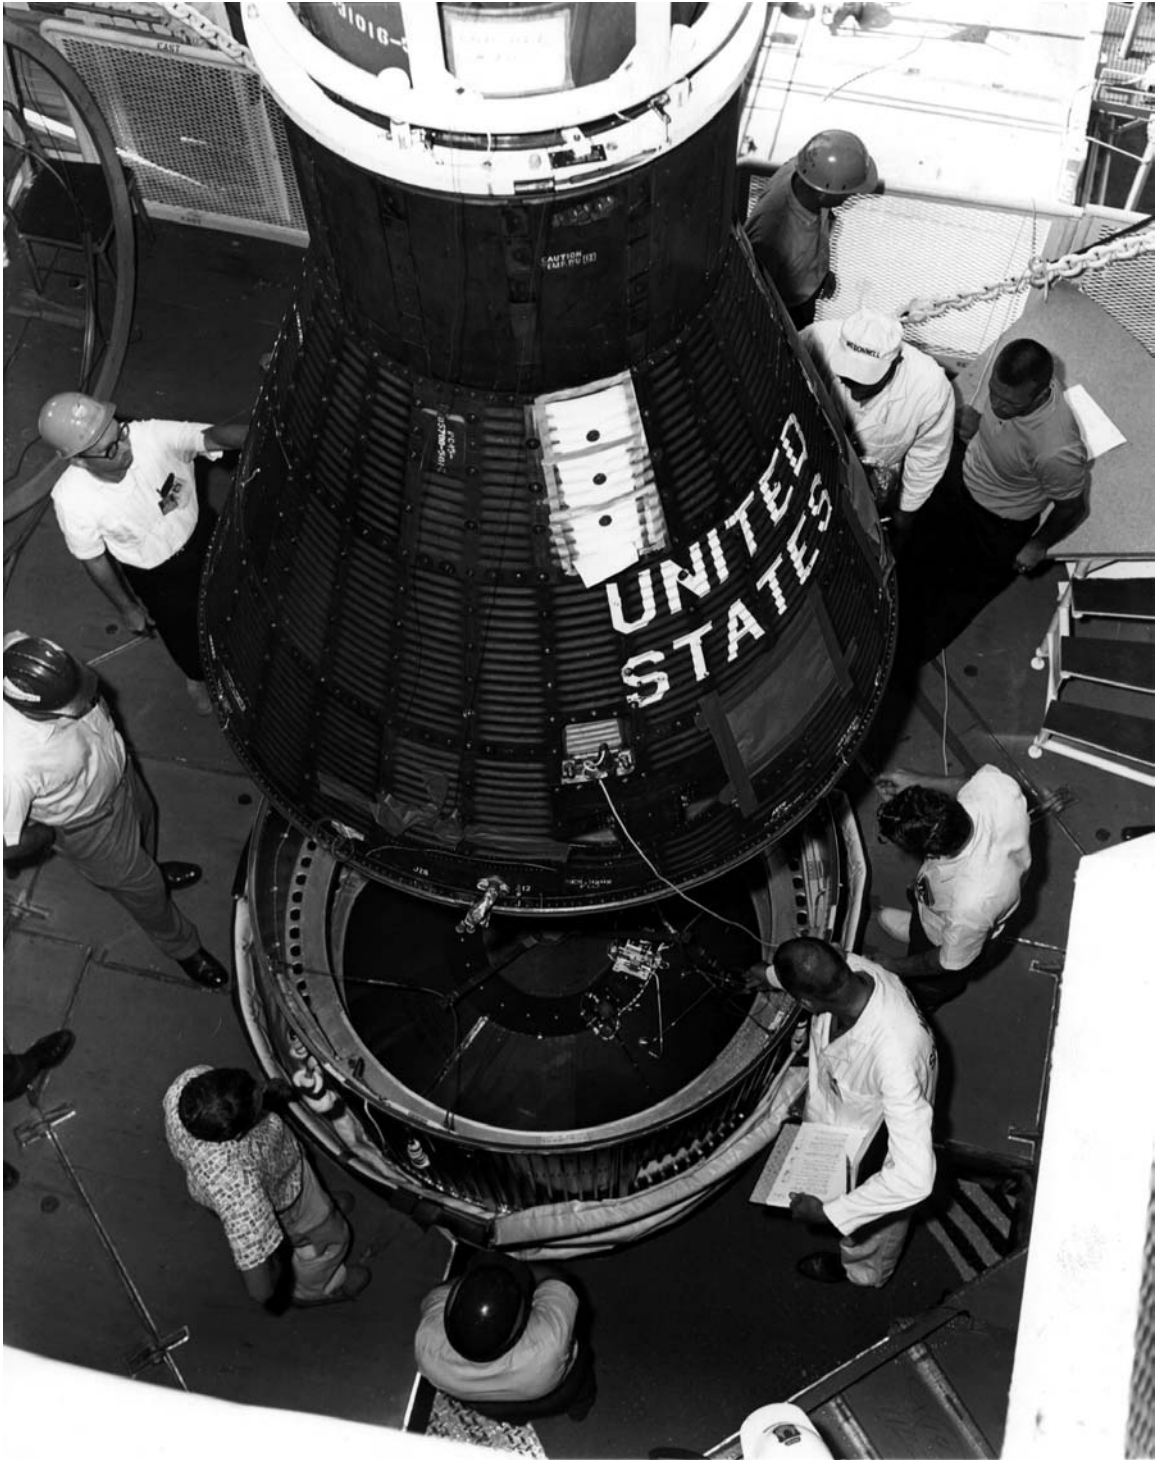
*Figure 16 MA-9 Booster Mating*

Figure 16 Reveals quite a few markings.

We have the normal J26 and J12 markings. At (100°, 107'') we see the marking

RCS. H2O2

## FILL

The marking at (80°, 105'') are harder to discern. It appears that the top line says AUTO and the the bottom line ends with VENT.

The marking at (50°, 105'') is even harder to make out. The top line might read AUTO PURGE

At (100°, 184'') just below the RCS jets on the recovery section we see what appears to be

CAUTION

TEMP. P/U [12]

Where the 12 (or perhaps it is some other number) is in a box.

Some other markings appear to be on protective covers on the S/C band antenna and the dielectric window of the antenna fairing.

There are also some other markings near the base at 175 degrees and 185 degrees but these are very hard to read.

Also note that at 185 degrees high up on the conical section a data marking appears inside the sixth bead from the top. It appears to contain the words TEMP. P/U although this might not be the entire wording.

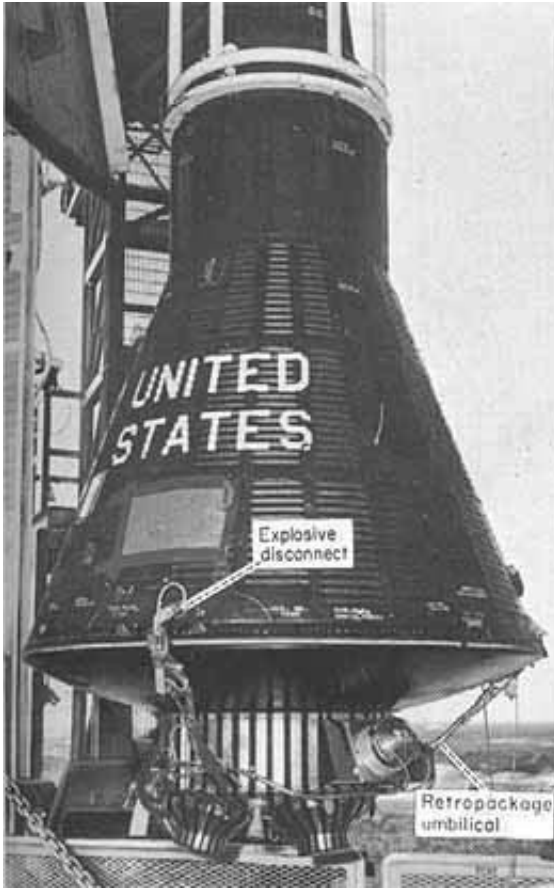
*Figure 17 MA-9 Being hoisted to top of the Atlas*

Figure 17 Shows the vehicle from another angle. A very good view from a similar angle is at <http://images.ksc.nasa.gov/photos/1963/high/63-MA9-61.jpg>

This view is from approximately 200 degrees. At (250°, 108") I see

MAN. H2O2  
FILL

There appears to be a symbol above this which might be a ? or a hoist mark, and some indecipherable text to the left of that. There are also markings in two beads below the roll RCS jets nearby. The J12 marking is there but in shadow.

At (220°, 110") we see what looks like

MAN. RC.  
VENT

Instead of RCS it might say H2O or H2O2 but I'm not sure.

At (200°, 110") I see

MAN. H2O2  
DRAIN, PURGE

There is another marking in the 3<sup>rd</sup> bead from the bottom at 185 degrees. At (175°, 111”) it looks like

AUTO H202  
DRAIN, PURGE

Another TEMP P/U caution seems to be in the bead at (200°, 147”) as well as a TEMP PU caution under the pitch RCS on the recovery section similar to that seen on the other side. It appears that these markings are under all four pitch/yaw thrusters on the recovery section.
